# Emergency Repairs to White Horse Road Bridge

## EMERGENCY REPAIRS TO WHITE HORSE ROAD BRIDGE

**Location:** Lindenwold, Camden County, New Jersey  
**Client :** Camden County Department of Public Works

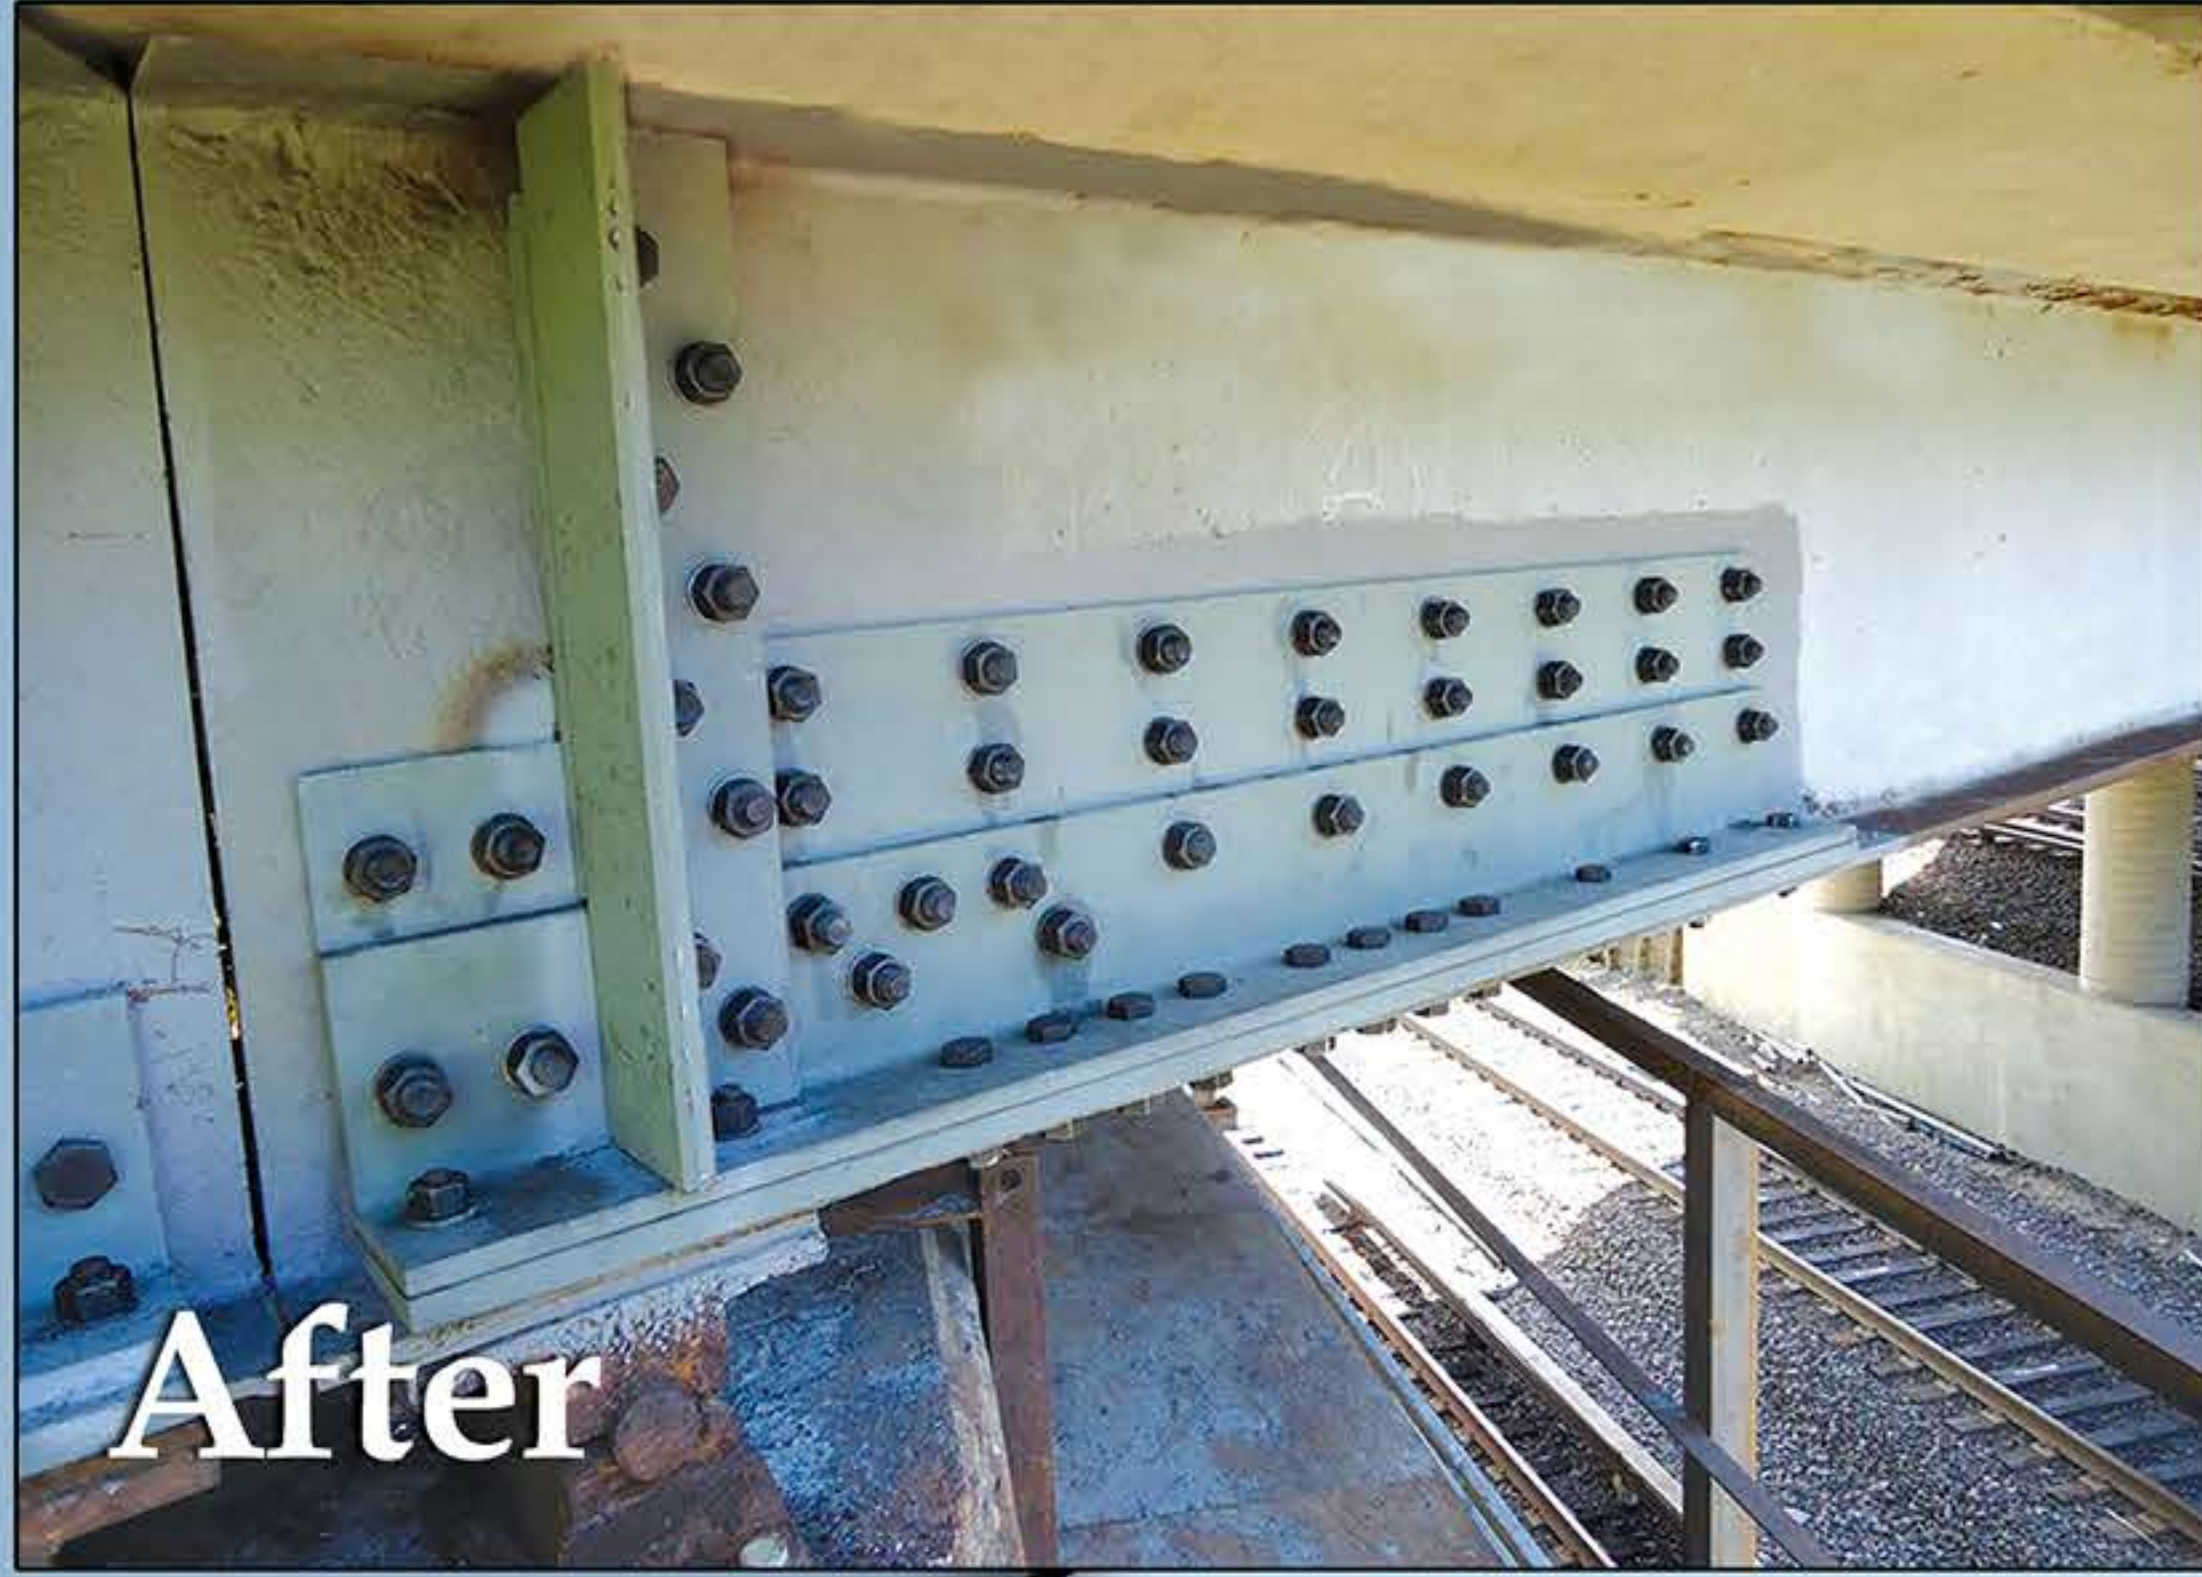
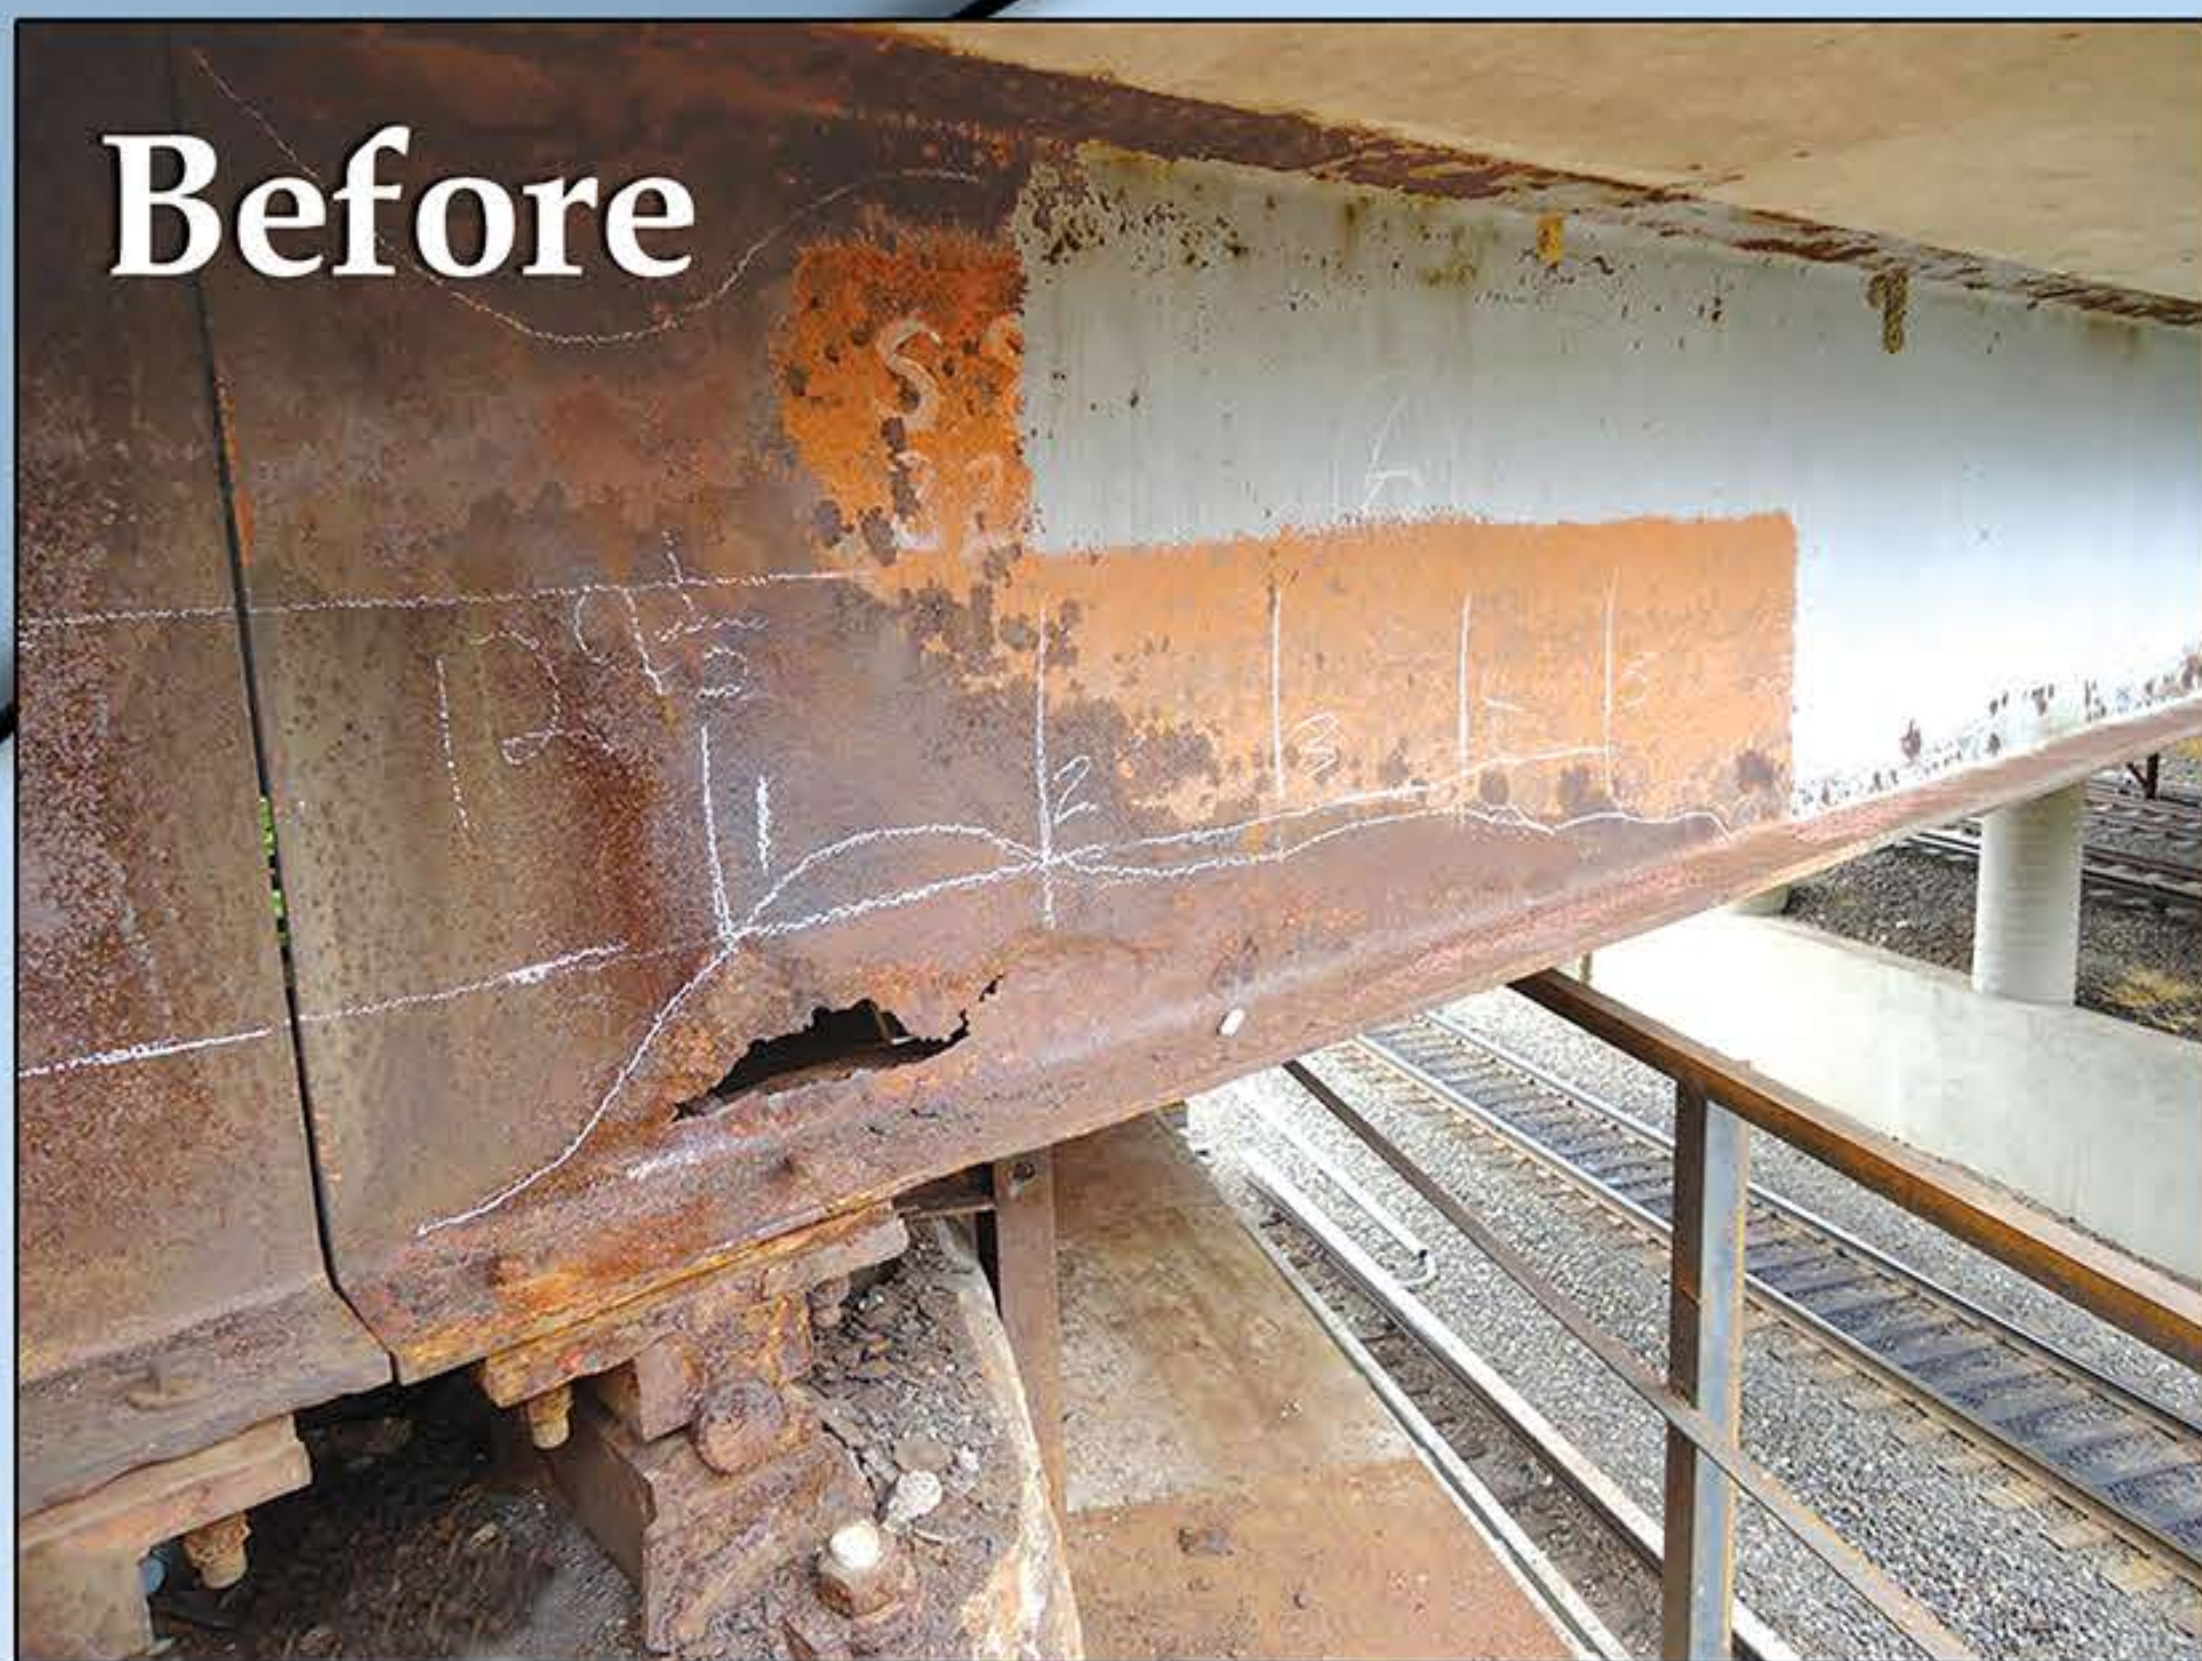
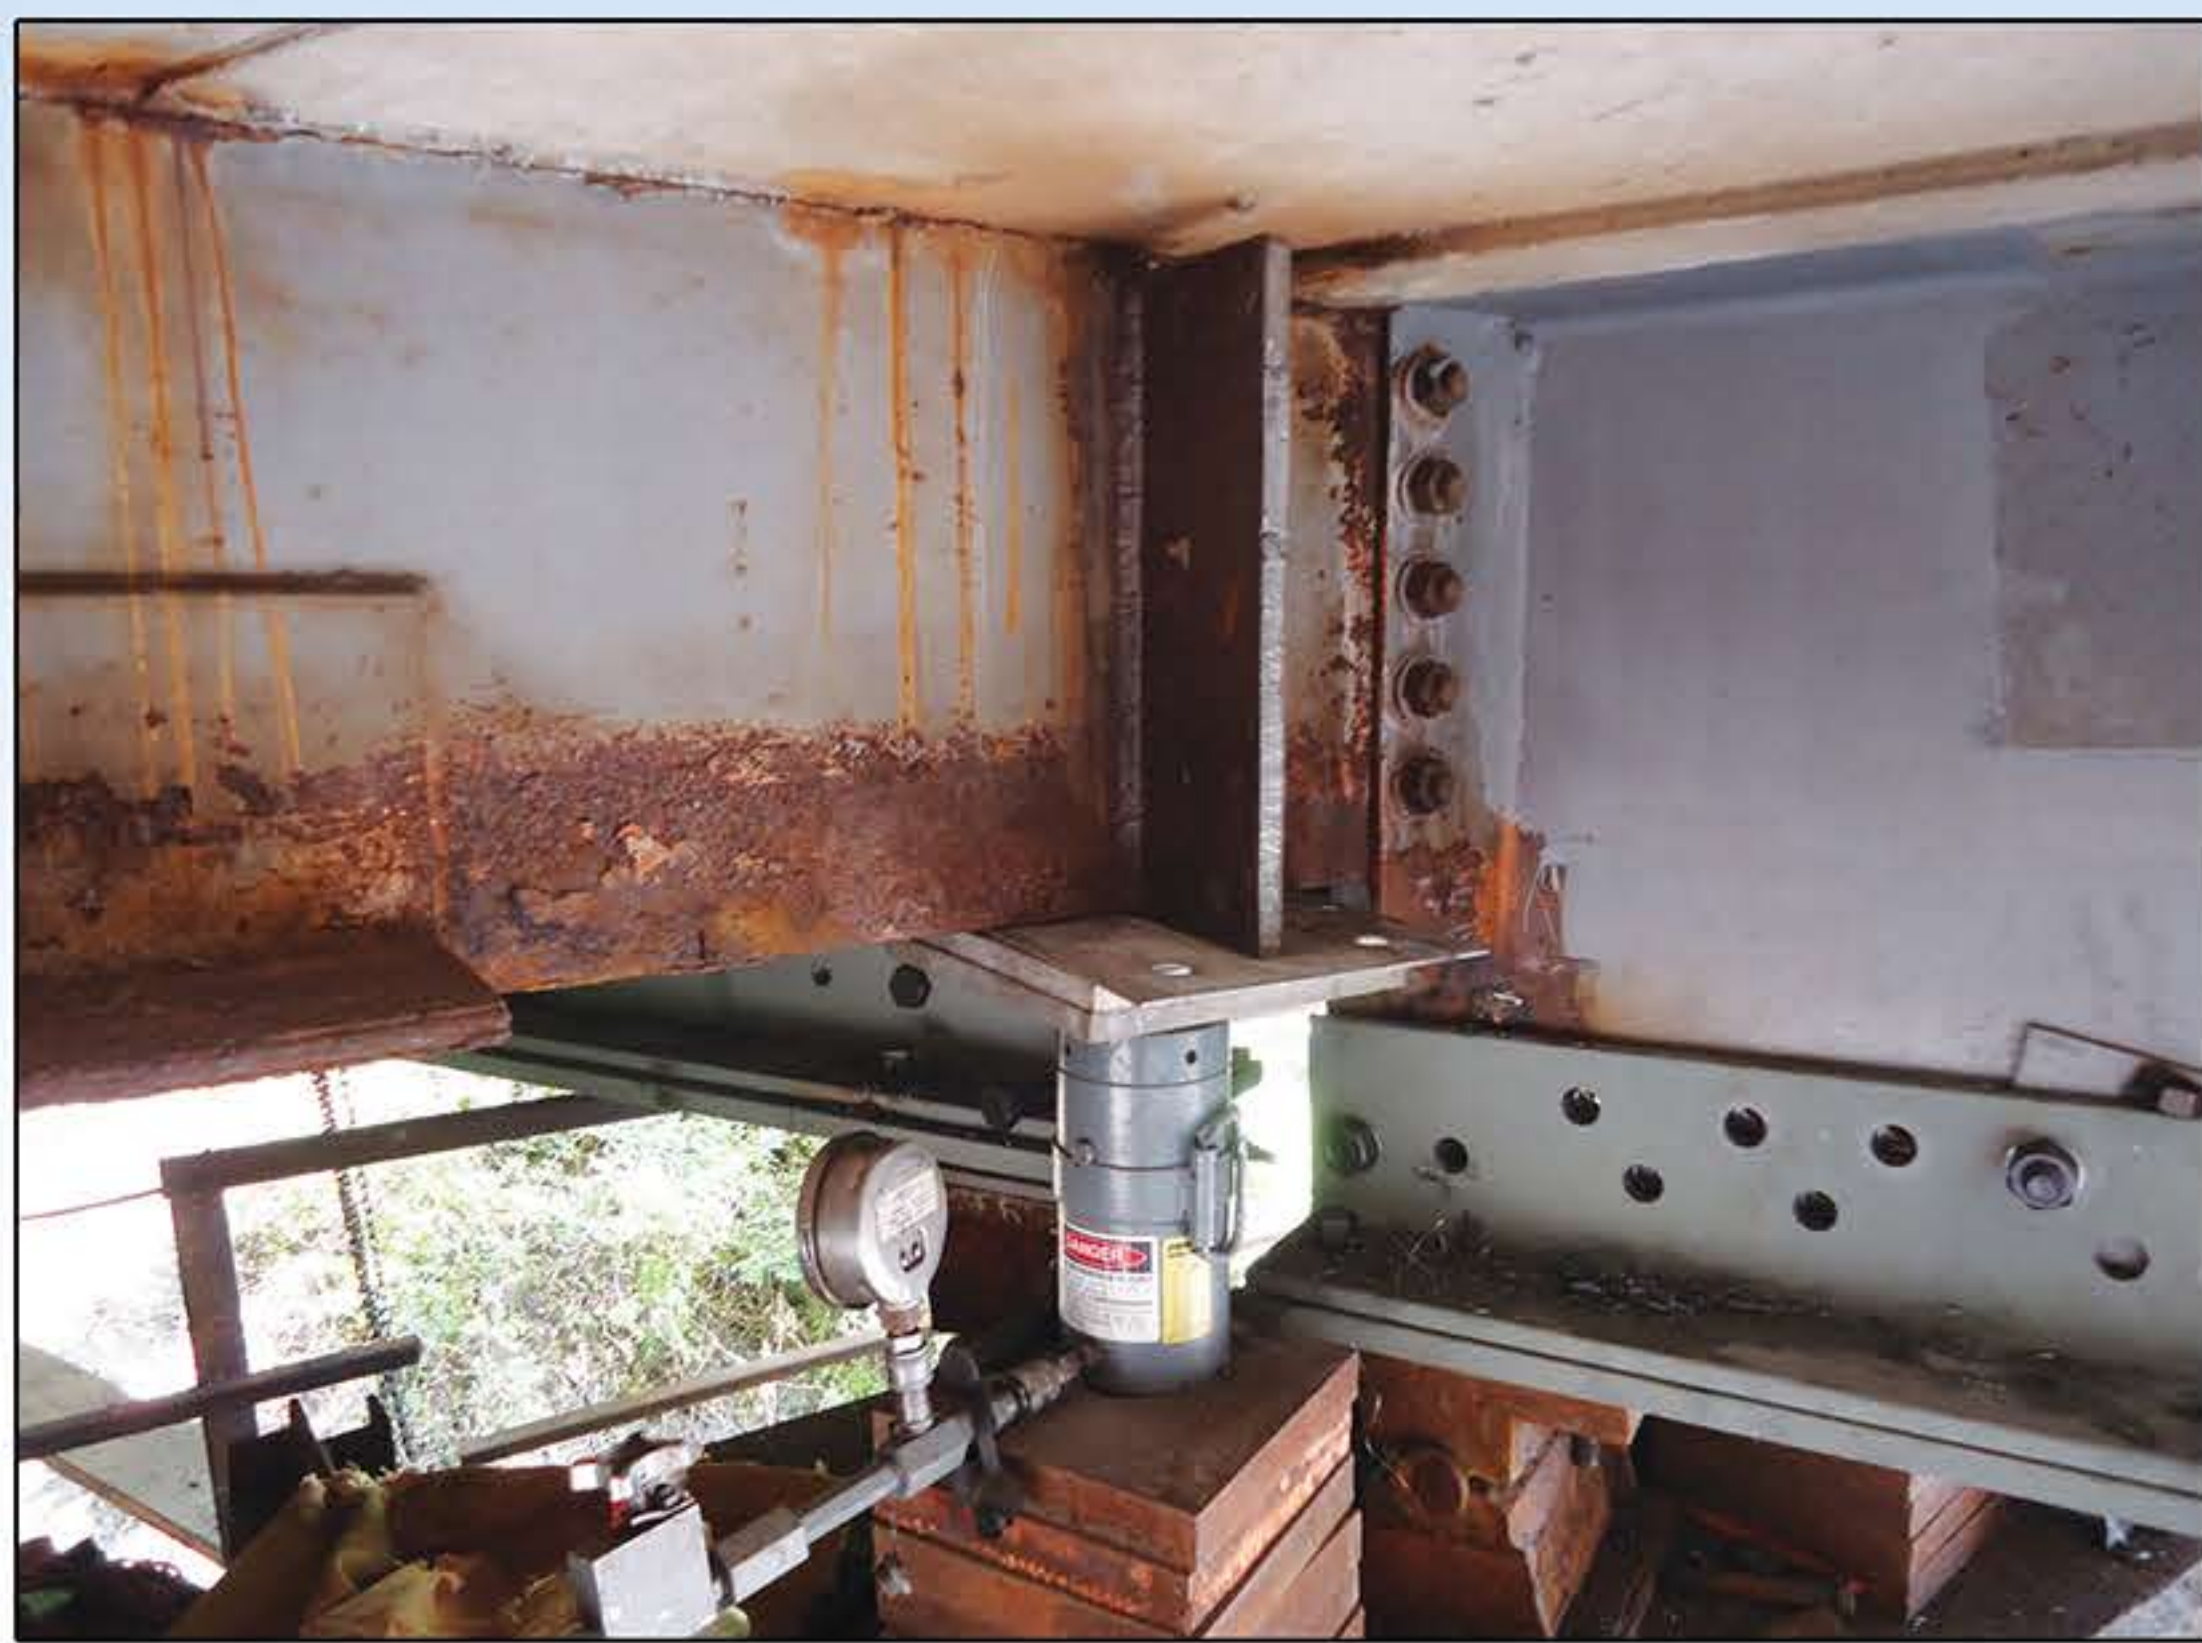
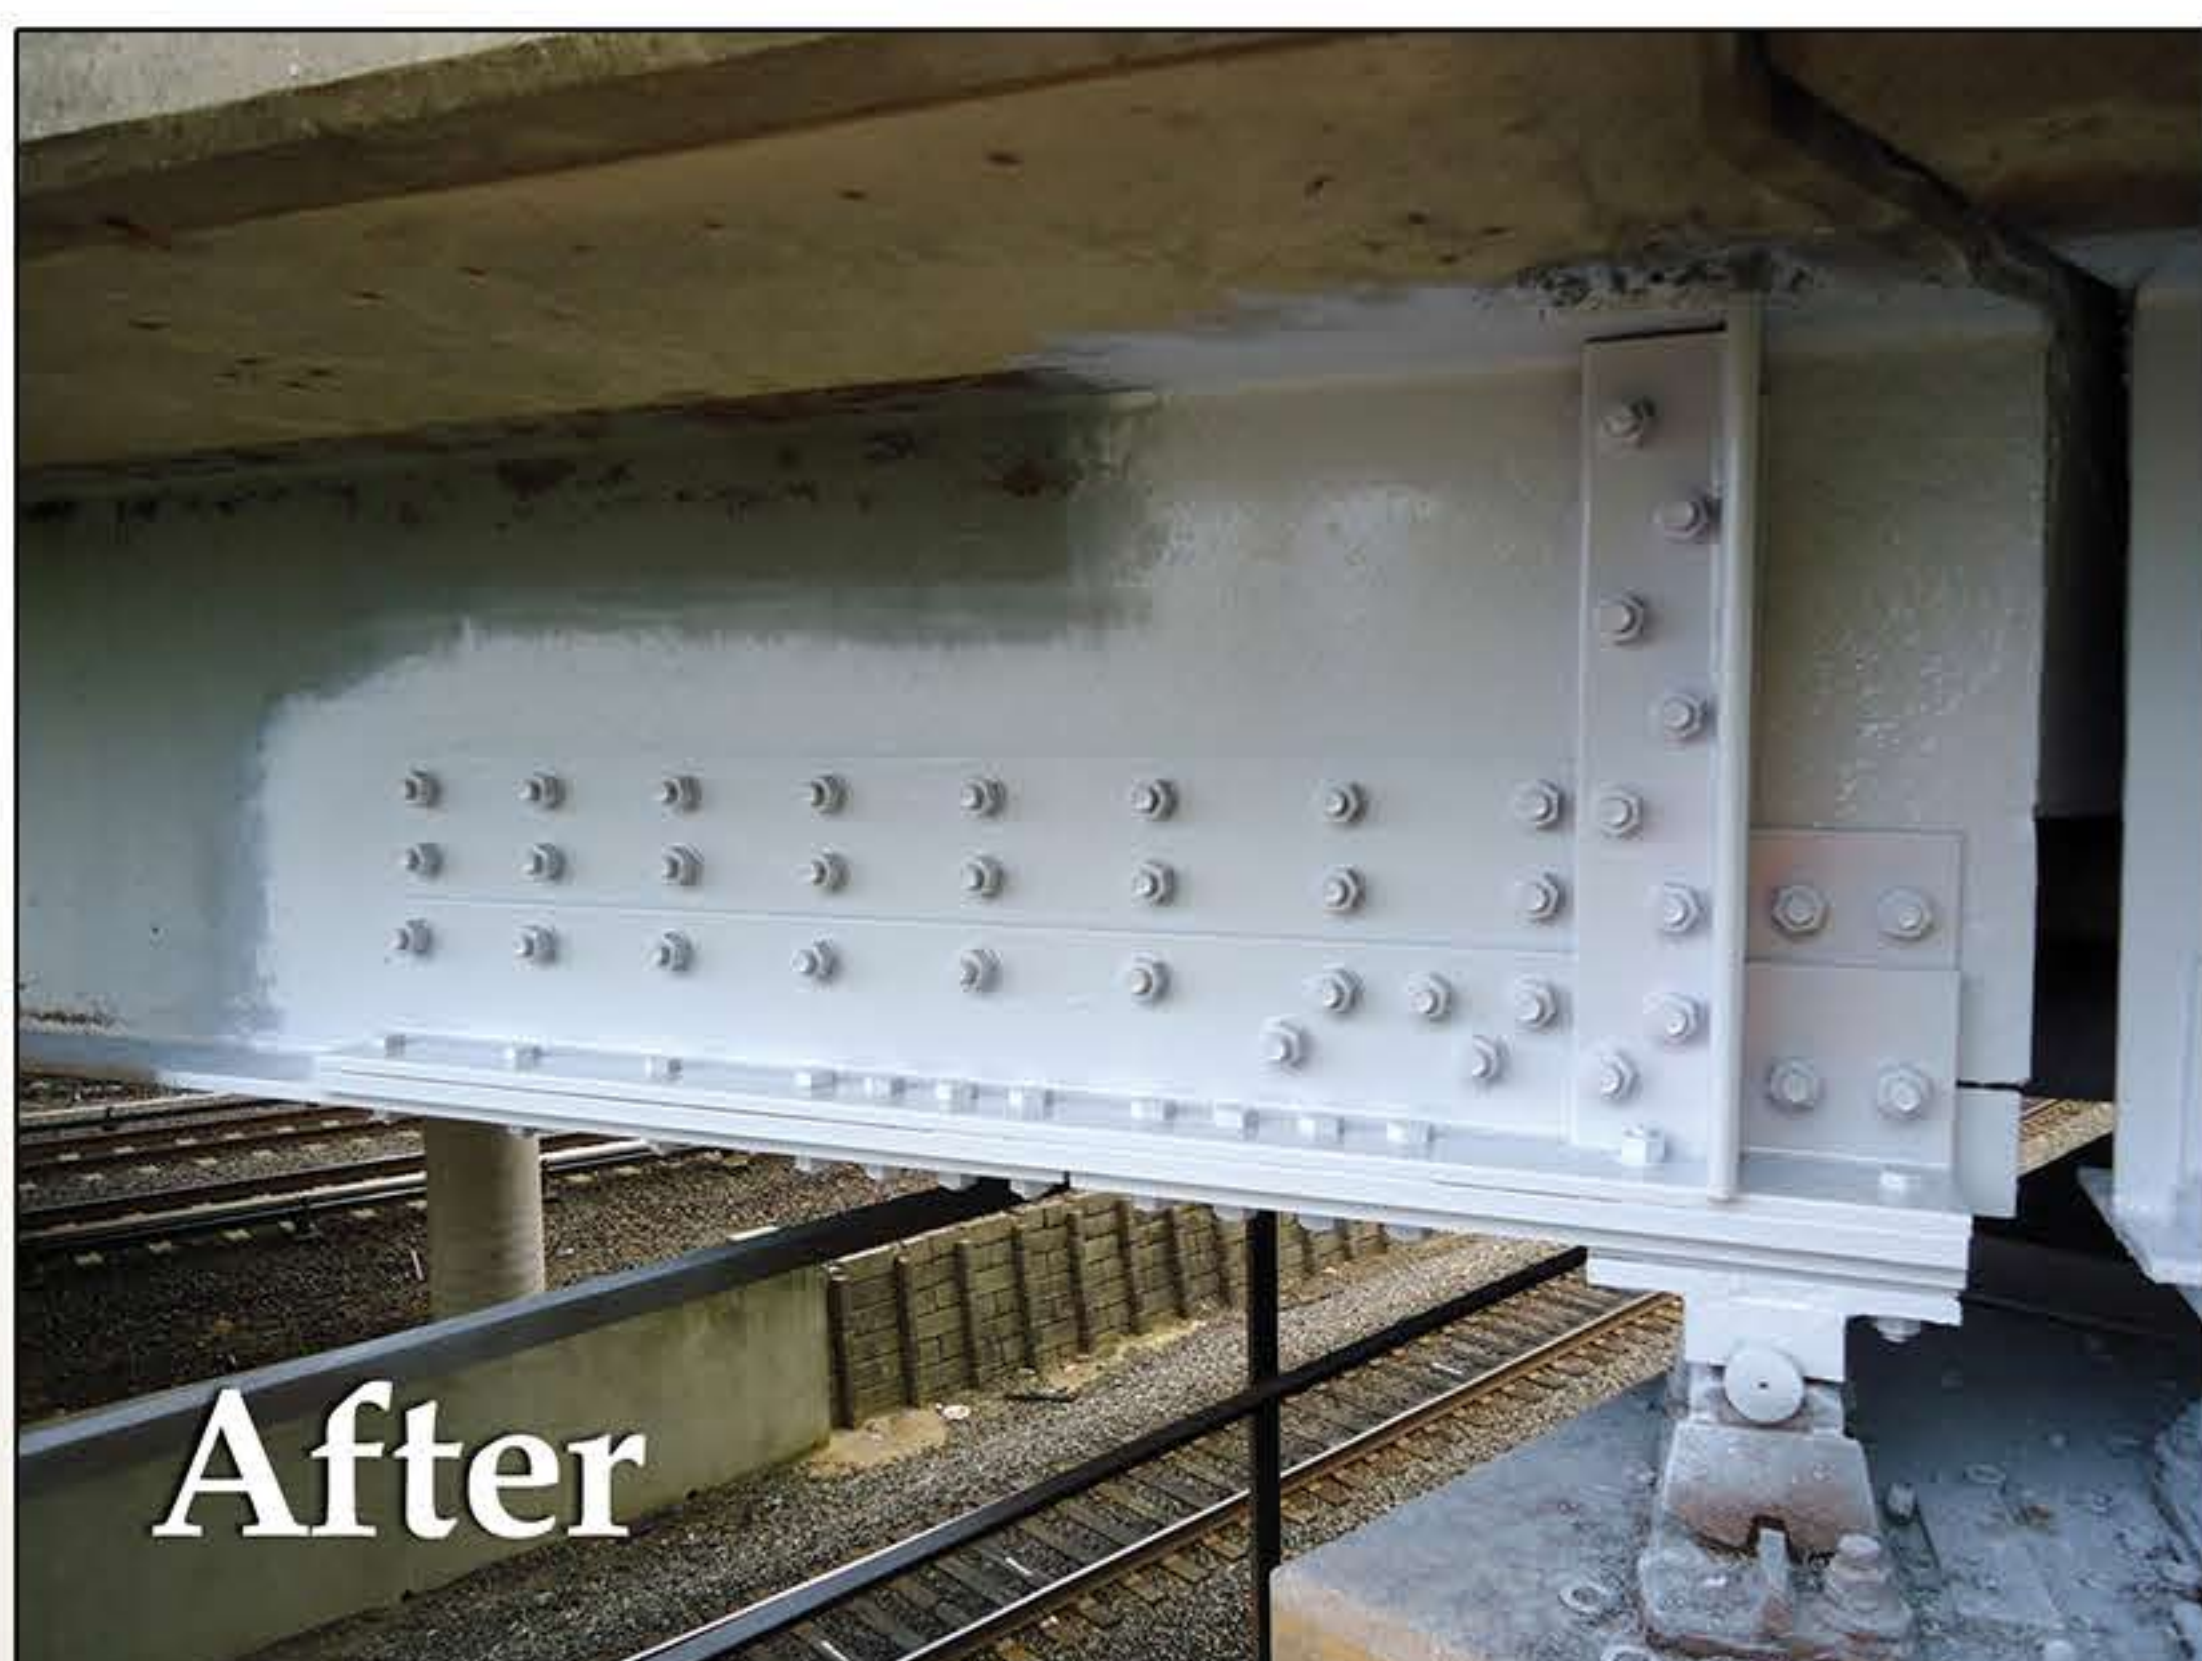
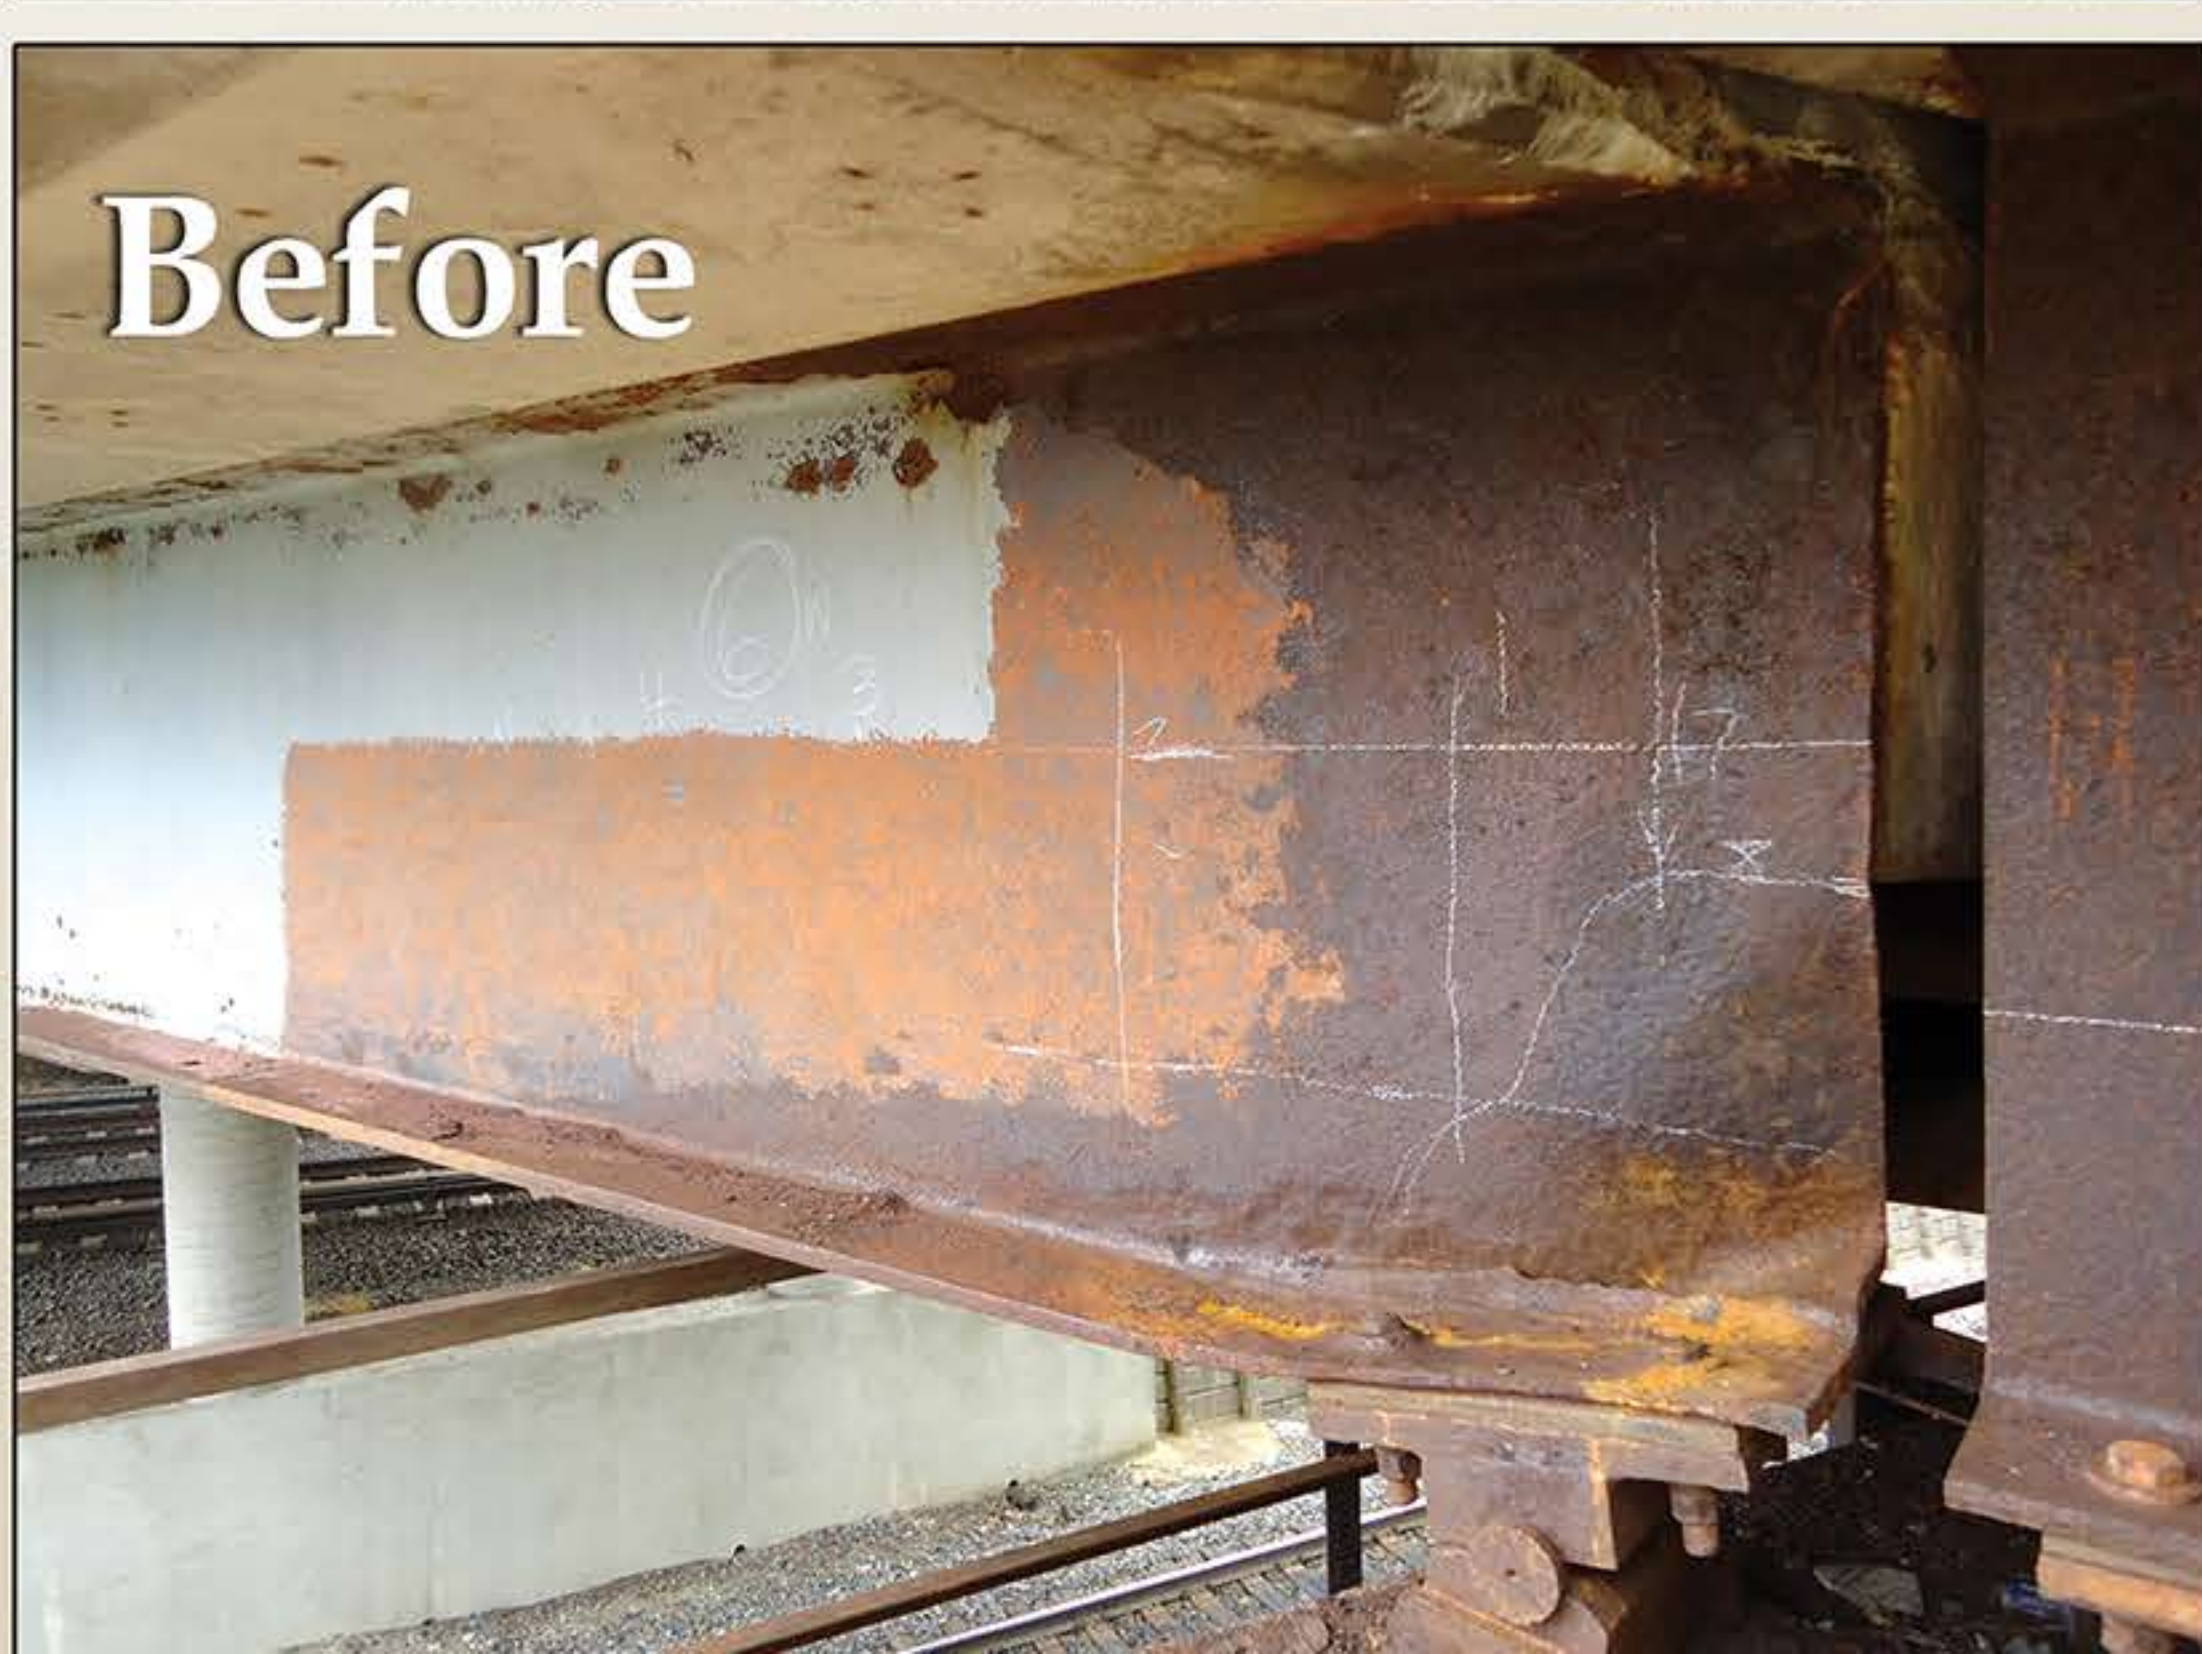
During 2014, the bridge experienced severe corrosion of the beam ends at the bearings due to deteriorated deck joints. Eventually the conditions led to localized web-crippling type failure at the fascia and first interior beams, causing vertical displacement of the deck slabs. The partial failure of the beams prompted an emergency inspection by KSE on June 25, 2014, and a subsequent closure of the bridge to all traffic.

The impact of the lengthy detour to bypass the bridge would be severe to the local economy if the bridge remained closed for an extended period. KSE was commissioned by the County to implement an accelerated pseudo-design-build approach that involved extensive daily on-site interaction with the contractor and design modifications on the fly due to field conditions. A total of 56 beam ends with advanced deterioration were repaired using new structural steel angles and plates, which were field-bolted to the existing beams to restore full load capacity.

The choreographed operation required close coordination with key stakeholders including Camden County, local law enforcement, DRPA, PATCO, NJ Transit, and the General Contractor. On September 24, 2014, approximately twelve weeks after the initial closure, the bridge was re-opened to full unrestricted traffic after all repairs were completed successfully.
